SECTION CORNER RECORD

SW 800-800

BOONE COUNTY SURVEYOR'S OFFICE

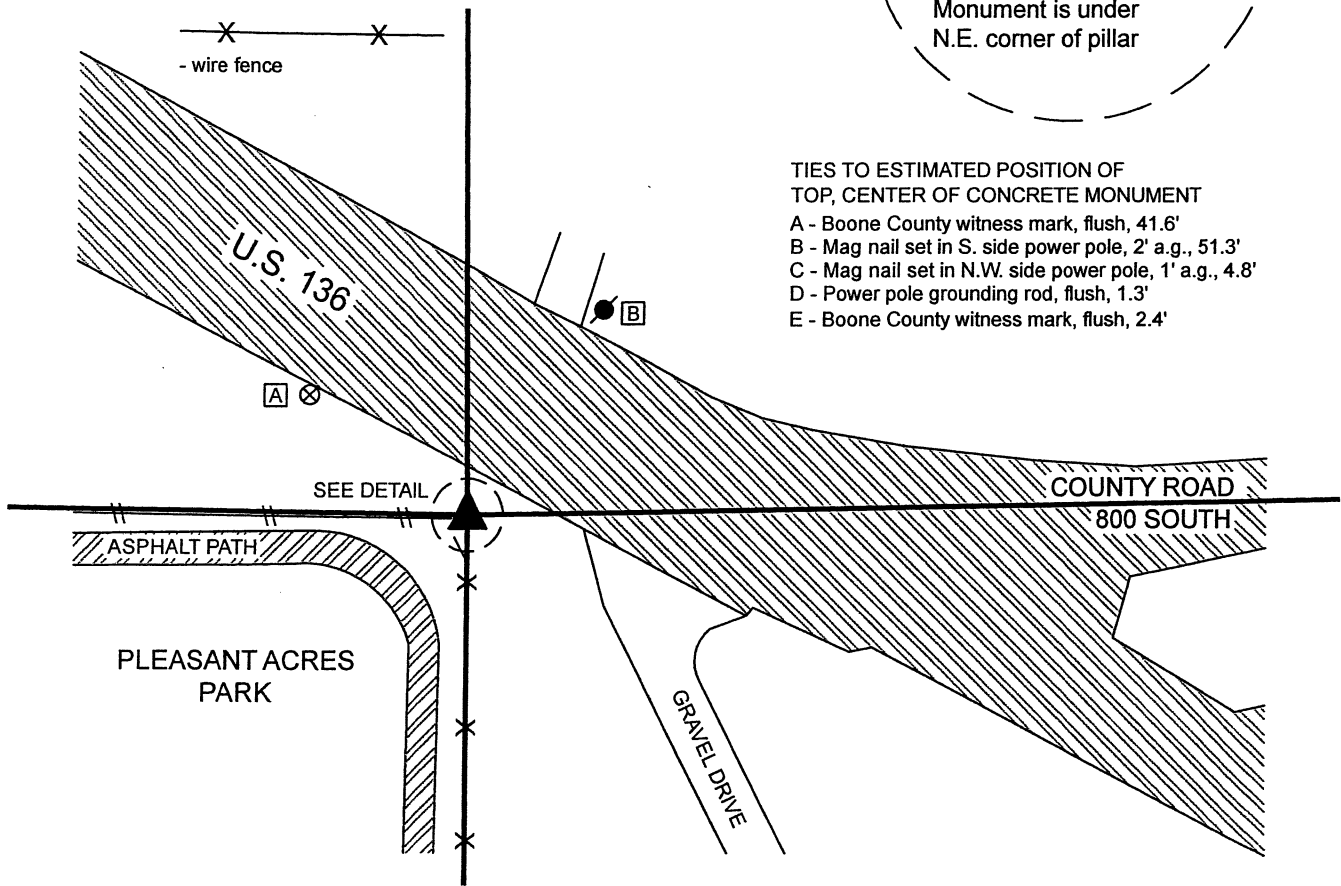
CORNER WITNESS DETAIL

TIES TO ESTIMATED POSITION OF TOP, CENTER OF CONCRETE MONUMENT

- A - Boone County witness mark, flush, 41.6'
- B - Mag nail set in S. side power pole, 2' a.g., 51.3'
- C - Mag nail set in N.W. side power pole, 1' a.g., 4.8'
- D - Power pole grounding rod, flush, 1.3'
- E - Boone County witness mark, flush, 2.4'
