# SECTION CORNER RECORD

## BOONE COUNTY SURVEYOR'S OFFICE

NE 900-000

① S.E. Corner, Section 13  
N.E. Corner, Section 24  
T 20 N, R 1 W

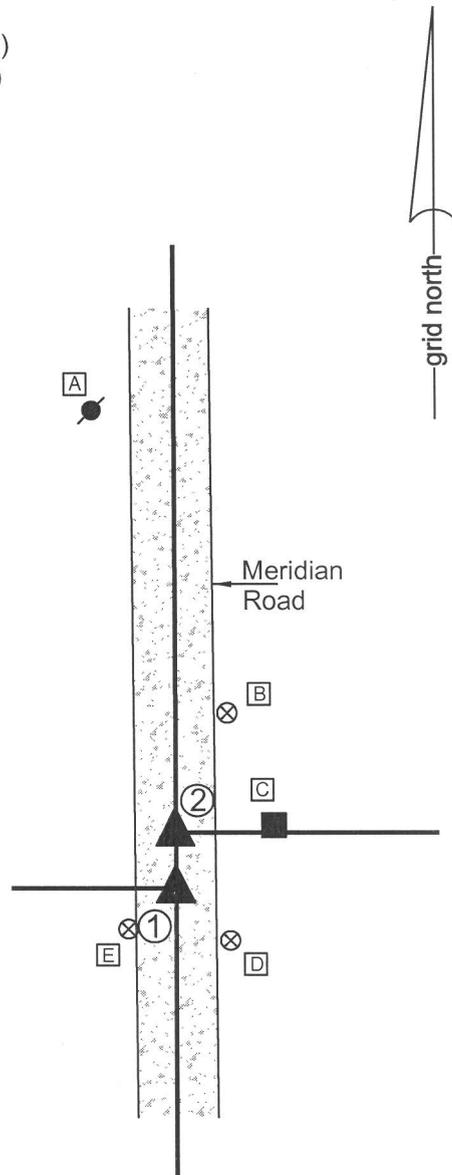
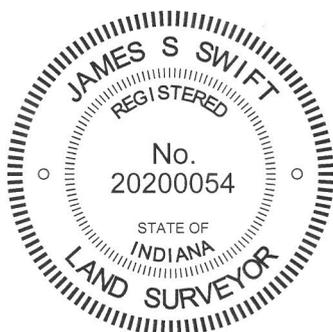
### CORNER WITNESS DETAIL

Distance between corners = 11.77'

- A - Mag nail set in S.E. side power pole, 2' a.g., 100.8' to corner 1, 89.2' to corner 2
- B - Boone County witness mark, flush, 38.4' to corner 1, 27.3' to corner 2
- C - Mag nail set in W. side wood post, 1' a.g., 22.5' to corner 1, 18.1' to corner 2
- D - Boone County witness mark, flush, 15.7' to corner 1, 25.3' to corner 2
- E - Boone County witness mark, flush, 13.1' to corner 1, 22.5' to corner 2

Boone County witness mark is a 3/8" diameter x 2' long rebar bearing a metal cap stamped "Boone County Witness Point."

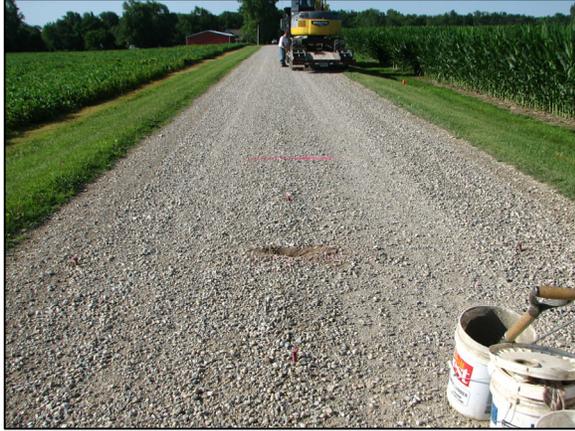
View prior to excavation, looking across the corners and south along Meridian Road.

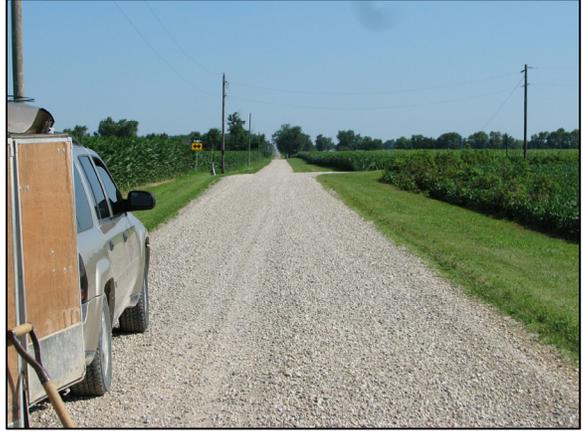
View prior to excavation, looking north along Meridian Road from above the closing corner.

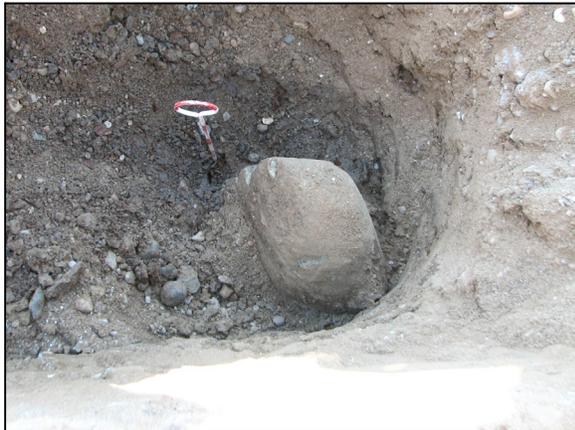
The stone found at the closing corner. The chaining pin is stuck in the fragments of wood stake found at the northeast corner of the stone.

After the stone was found, a probable location for corner one was determined and excavation was performed at this location. Here, a piece of wood was found at 20 inches deep. This piece of wood appeared to be a fragment of an old post being squared off on the sides and approximately 4 inches by 3 inches by at least 4 feet long. The piece of wood was found embedded in the clay layer below the road and lying perpendicular to the north-south road. An 18 inch fragment of the post was removed from the road, measured and analyzed. The remainder of the post was left in the ground as found. The full length of the post was not determined and it appeared to extend yet further east and west than that portion which was exposed. Careful analysis of the post indicates that in the approximate center of the fragment which was removed, hence directly south of the stone, a vague notch is visible. The notch is not deep and was not observed at the time the post was found. However, after the post dried in the open air and the surface of the post cracked slightly, the notched part of the post became apparent. One edge of the notch bears distinct evidence of having been chiseled. The center of the post was found at 11.8 feet south of the top, center of the stone. The record closing distance is 19 links, or 12.54 feet. This distance is also stated in the 1879 records. It is noted that while the distance between the post and stone was found to be less than the record distance, the distance measured between post and the fragments of the wood stake at the northeast edge of the stone at corner two was very close to the record distance.

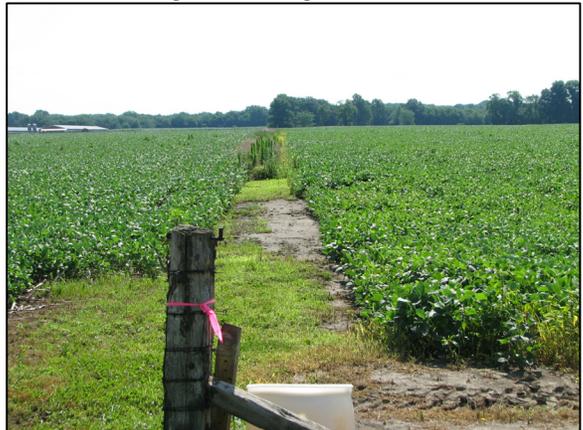
View from above the stone at the closing corner looking east along the field division line.

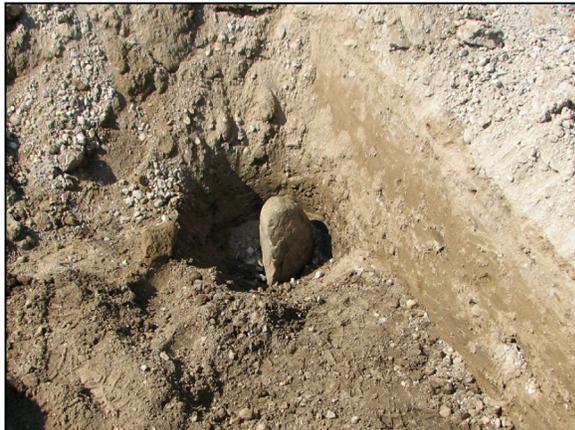
View of the stone found at the closing corner from above and northeast.

Two other features of this corner and the monumentation found are notable. Although the record clearly states that the stone was "marked (+)," no marks were found on the stone. Perhaps a mark was present but was sufficiently vague to prevent detection in the field on July 9, 2014. As stated above, the notch on the crosslaying post was not observed on that date but was subsequently observed upon more careful inspection and after changes in the character of the surface of the wood. As the stone was left in place, buried under the road, with a substantial monument placed above it, further inspection was not practical. The dimensions of the stone precisely matched the 16.9.6 dimensions noted in the 1879 record.

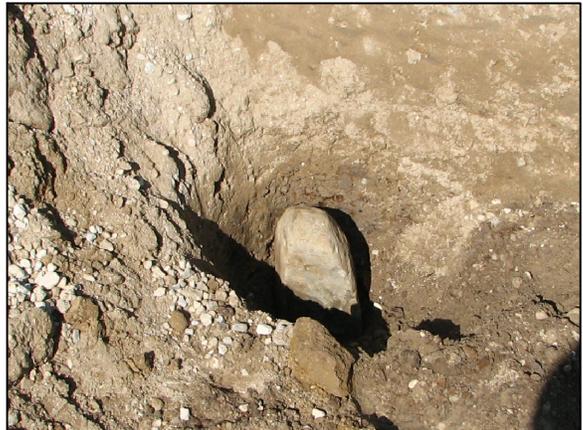
View of the stone found at the closing corner from above and east/northeast. Note the flat, vertical face of the east side of the stone.

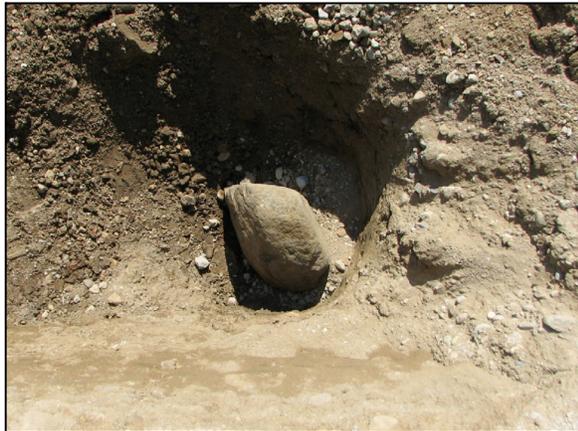
The stone found at the closing corner from above and west.

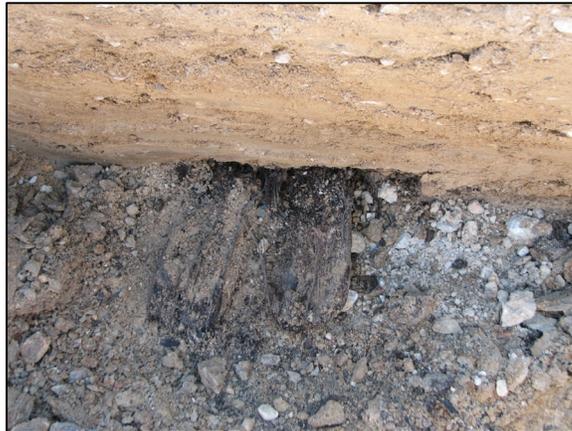
The eastern portion of the "crosslaying" as found situated perpendicular to the meridian line at the standard corner.

Analysis of the record and the found evidence yields the following conclusions. It is believed that the wood post found under the road and discussed above represents the monument referred to as the "crosslaying" in the 1879 record. The object was found lying perpendicular to the meridian line, or 'crosslaying' the meridian line, with a notch evidently chopped into it. The notations in the BCS Surveyor's Record indicate that this 'crosslaying' was found at the closing corner (corner two), not the standard corner (corner one.) It is believed that the crosslaying is misreferenced to the wrong section. Notably, it can be proven that the record immediately below the reference to the crosslaying, made on the same date, refers to an object in the wrong section. Hence, it appears the record keeping was problematic on that day with respect to which corner was which and what section was what. This is not particularly surprising, given that there are two corners, 12 feet apart, which represent the corners for four different sections in two different ranges, east and west of the 2nd Principal Meridian. With respect to the stone found at the closing corner, several observations are noted: The record clearly indicates that the stone was marked by the County Surveyor but not set by him. The stone was found oriented in a different manner than is typical of corner stones set by the County Surveyor but in a manner which makes sense given that the landowners who set the stone were marking the line to the east, as noted above. A wood stake was found at the northeast corner of the stone. The stone is slightly closer to the 'crosslaying' than the record 19 links, but the wood stake was quite close to that record distance from the 'crosslaying.' It is the opinion of the undersigned that the most probable occurrence on February 25, 1879 was that the County Surveyor or his crew found the post which they referred to as the 'crosslaying' defining the north-south position of the standard corner, chopped a mark in it to define the east-west position of that corner and set a wood stake to mark the position of the closing corner. At some subsequent date, the interested 'parties' set the stone next to the wood stake, leaving the stake in place, and setting the stone in a manner inconsistent with that typically adhered to by the County Surveyor. If this is true, it would hold, then, that the stake marks the true position of corner two and that the stone is slightly south and west of the corner. However, given the inherent conjecture of the above statement and the presence of the apparently undisturbed stone, the stone was held as marking the closing corner. The standard corner was set at the north-south position of the found 'crosslaying' on the prolongation of a line connecting the stone with the standard corner approximately one half mile to the north, where the meridian line crosses the county boundary. Hence, the meridian line bends at the standard corner, as per the original federal procedures, and the distance between the two monuments is slightly less than the record closing of 19 links. As the notch on the crosslaying was not observed during the original fieldwork, it is not possible to state whether the Harrison monument at the standard corner is in the exact position of the notch. In light of the above conclusions, it is thought to be most likely that the Harrison monument is slightly west of the position of the notch on the crosslaying.

The other feature of this corner which merits comment is with respect to the wood post, accepted as being the 'crosslaying.' This term has not been found mentioned elsewhere in the BCS Surveyor's Record, but as discussed above, fits well with the observation that the post was found laying perpendicular to and across the meridian line. The age of the post is not known, but apparently it was already present in 1879. As noted above, the post is 3 inches by 4 inches by at least 4 feet long. This is quite small for a fence post and rather large for a survey stake but is similar to the dimensions for a monument proscribed by Edward Tiffin's Instructions to the federal Deputy Surveyors, in force at these corners were originally established. It is possible that this post represents the original wood post set to mark this corner in 1819 during the original federal survey of the Second Principal Meridian and the ranges to the west. No further proof of this offered, but the conjecture is sufficiently interesting to merit mention.

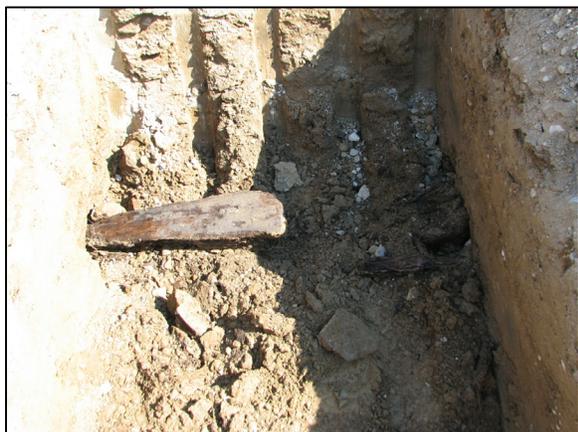
The east and west portions of the "crosslaying." The western portion had been removed and placed back in approximately the original position.

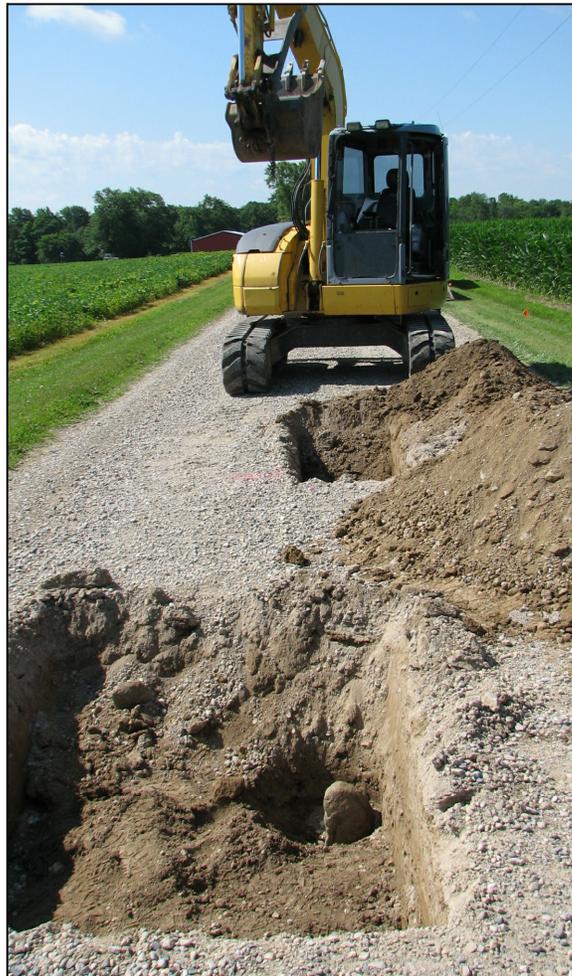
View from the north, looking across the stone at corner 2 and the area of excavation at corner 1.

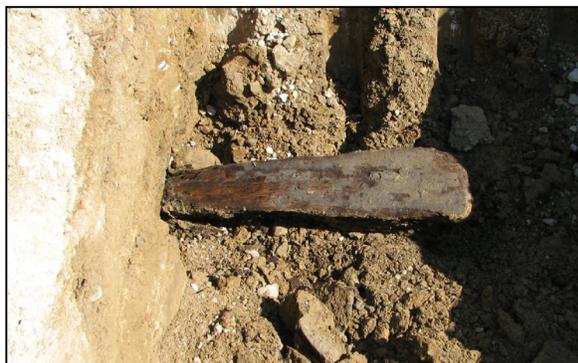
The west portion of the "crosslaying." Note that the clay in which this piece of wood had been embedded 'popped' off the wood upon excavation, leaving the wood looking remarkably clean, given that it was embedded in clay as originally found moments earlier.
