Union Township

SECTION CORNER RECORD

BOONE COUNTY SURVEYOR'S OFFICE

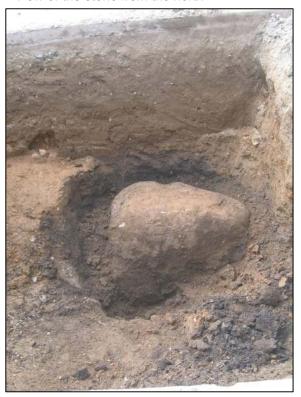
View of the stone from the north.

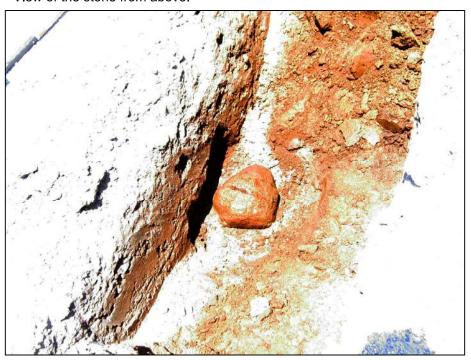
View of the stone from above.

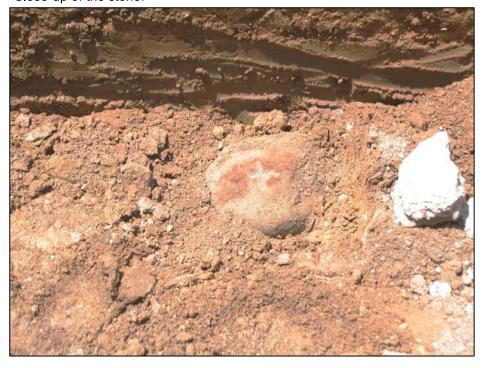
Close-up of the stone.
